Flightfax **ARMY AVIATION** RISK-MANAGEMENT INFORMATION July 2001 ♦ VOL 29 ♦ NO 7

UH-60 Main Rotor Blade Expandable Pin

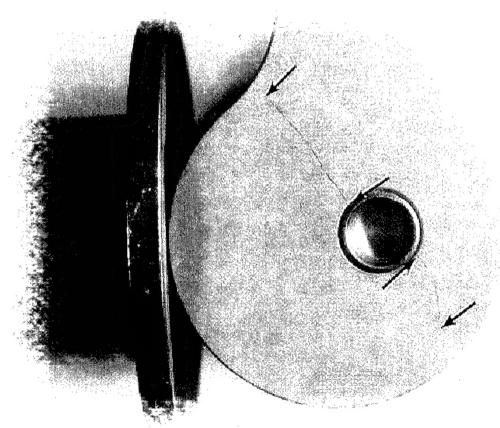
Summary of the **Problem:** A main rotor blade expandable pin was discovered with a crack in the cam handle that, if left uncorrected, could have resulted in a catastrophic failure and the loss of a main rotor blade. The material investigation indicated that the cracking was due to stress and corrosion. Pins currently in the inventory from APEX with serial numbers

0001-3800 are susceptible to this failure prior to normal wear out times because of a manufacturing defect. In order to control the risks these cracks present, the Army leadership has determined that the specified APEX pins are not safe for flight and must be removed. Additionally, all other main rotor blade expandable pins will undergo a one-time inspection with 10 power magnification for cracks and corrosion.

It is going to take a cooperative effort to ensure that we have safe aircraft to fly. Leaders must make sure that the SOF message is disseminated to all personnel and that all main rotor blade expandable pins produced by APEX are removed. This will

require a visual inspection of each aircraft to ensure all APEX pins are properly identified and removed. Additionally, leaders will have to ensure that appropriately trained and experienced personnel, technical inspectors, conduct the one time inspection of the remainder of the pins.

The Army leadership is developing a plan to provide replacement pins to the field at the earliest possible date. Until the replacement APEX pins become available, only pins manufactured by Avibank and Shur-lok Corporation are authorized for flight, and only after the appropriate one time inspection.
